Geotechnical Assessment of the Slopes of Hamamok Dam, NE of Koya, Kurdistan Region of Iraq

Abstract—The Hamamok Dam is an earthfill dam with a height of 25 m and a length of 125 m, constructed in 2011, located northwest of Koya town on a deep canyon-like valley that flows along the southeastern plunge of the Bana Bawi anticline, which forms Bawagi Mountain. The exposed rocks at the site belong to the Pila Spi and Gercus Formations; however, rocks from the Khurmala and Kolosh formations are exposed upstream from the dam's reservoir. The difference in the hardness of the carbonate rocks of the Pila Spi formation, which forms the uppermost parts of the cliffs surrounding the dam site, and those of the soft reddish brown clastics of the Gercus Formation caused steep slopes that suffered from slope instability problems. To perform a geotechnical study of slopes at the dam site, we have collected different field data to perform a kinematic assessment method using DipAnalyst 2.0 software and drawn the stereographic projections for the studied 10 stations using Stereonet v11 software. Besides, Bejerman's method, which is based on field data, is used to indicate the landslide possibility i

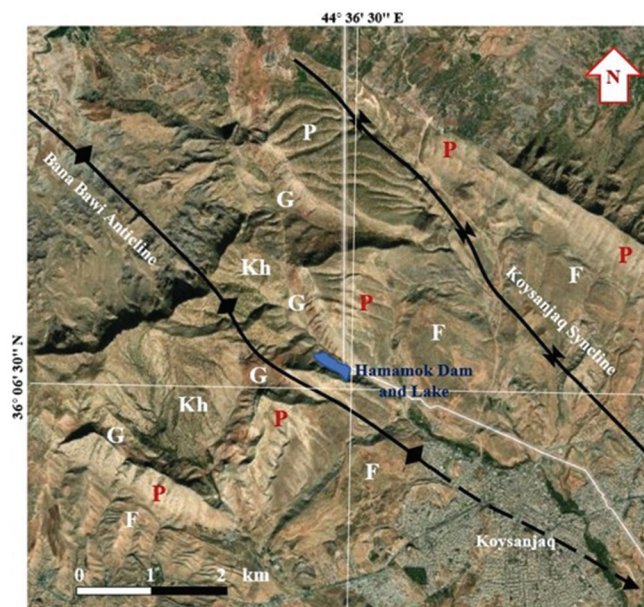
The steep slopes and cliffs are also well-developed at the dam site. These are attributed to the soft clastic rocks of the

Gercus Formation, which are overlain by hard carbonate rocks of the Pila Spi Formation Fig. 3.

Fig. 3. Giant flat irons on the southeastern plunge of the Bana Bawi Anticline and Koysanjaq Syncline. Geological Formations: Kh=Khurmala, G=Gercus, P=Pila Spi, and F=Fatha (Esriimage, 2023).

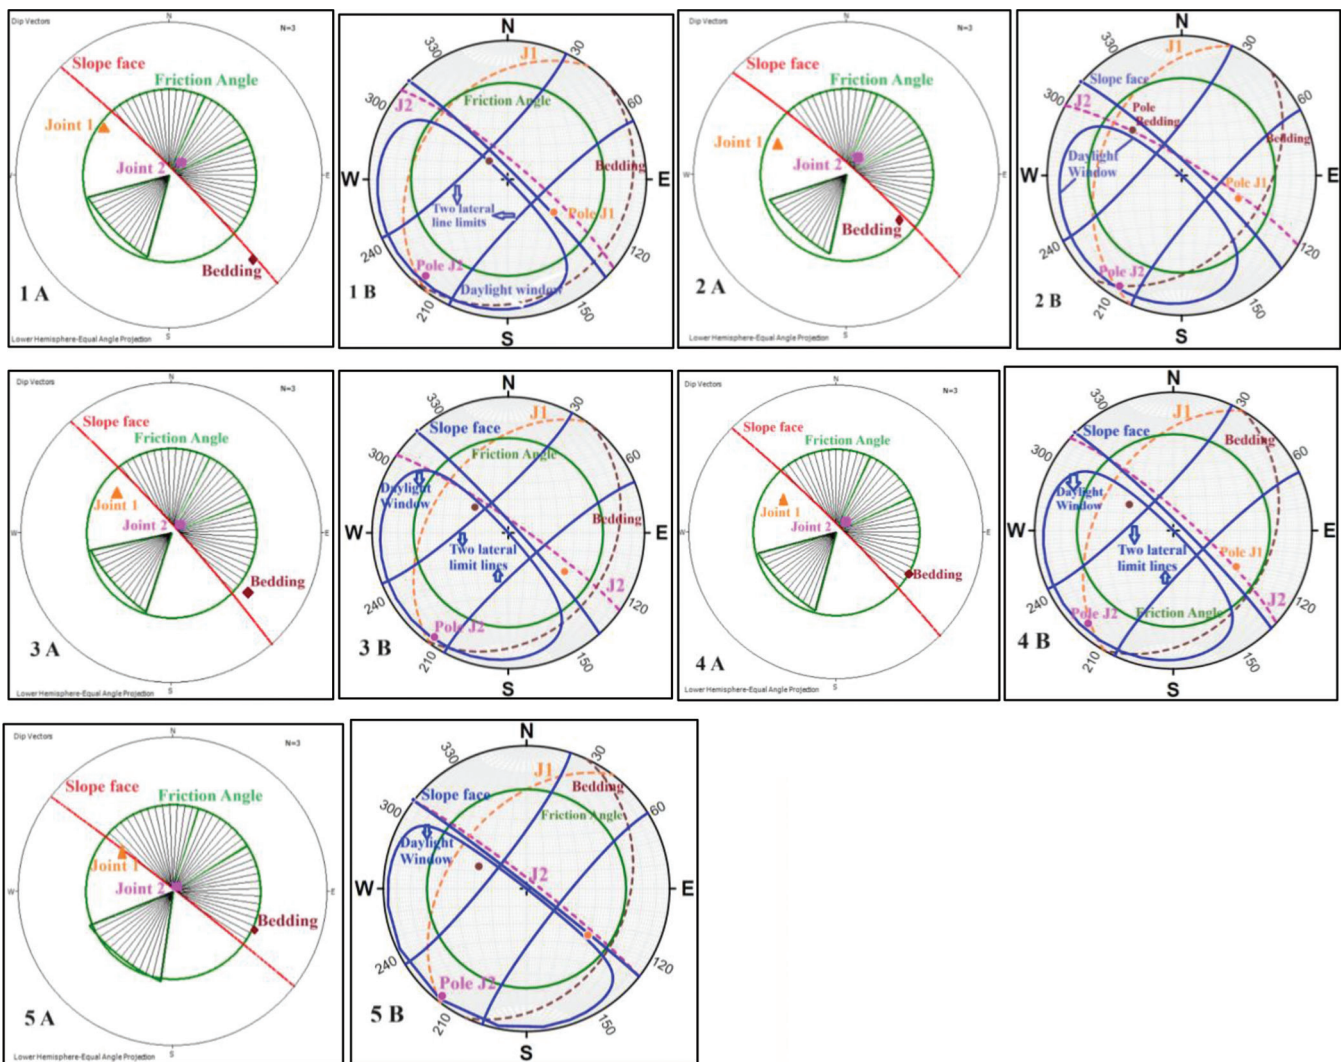
The stereographic projections and Dip analysis 2.0 diagrams are presented in (Figs. 4 and 5) for the right and left banks' stations, respectively. By DipAnalyst 2.0 software the factor of safety can be calculated for plane and wedge failure but we cannot obtain it for toppling failure. Therefore, the values of the factor of safety were obtained only for stations 1, 2, 3, 4, and 5, which are presented in Table IV. The values of Friction angle, Cohesion and rock density were acquired from the geotechnical study of the Haibat Sultan tunnel (Bosphorus Technical Consulting Corporation, 2012), which is located about 1.5 km east of the study area within the same rocks and same geological condition (Sissakian and Fouad, 2014). Whereas, the results of the Kinematic analysis of the studied 10 stations using Dip analysis 2.0 are presented in (Tables V and VI).

For all stations, in stereographic (Figs. 4 and 5) (1B, 2B, 3B, 4B, 5B, 6B, 7B, 8B, 9B, and 10B), the slope face with the daylight window (envelope) and two lateral limit lines are in blue. Joint 2 is pink in color, joint1 is in orange color, the bedding plane is brown and the internal friction angle is in green color. For Dip Analyst (Figs. 4 and 5) (1A, 2A, 3A, 4A, 5A, 6A, 7A, 8A, 9A, and 10A), the slope face is in red and joints 1 and 2 are in orange and pink color, respectively. The bedding plane is in brown and the internal friction angle is in green color, whereas the critical area is determined by the Dip Analyst software.

Fig. 4. Stereographic projections and Dip analysis diagrams of stations 1, 2, 3, 4, and 5 of the Hamamok Dam.

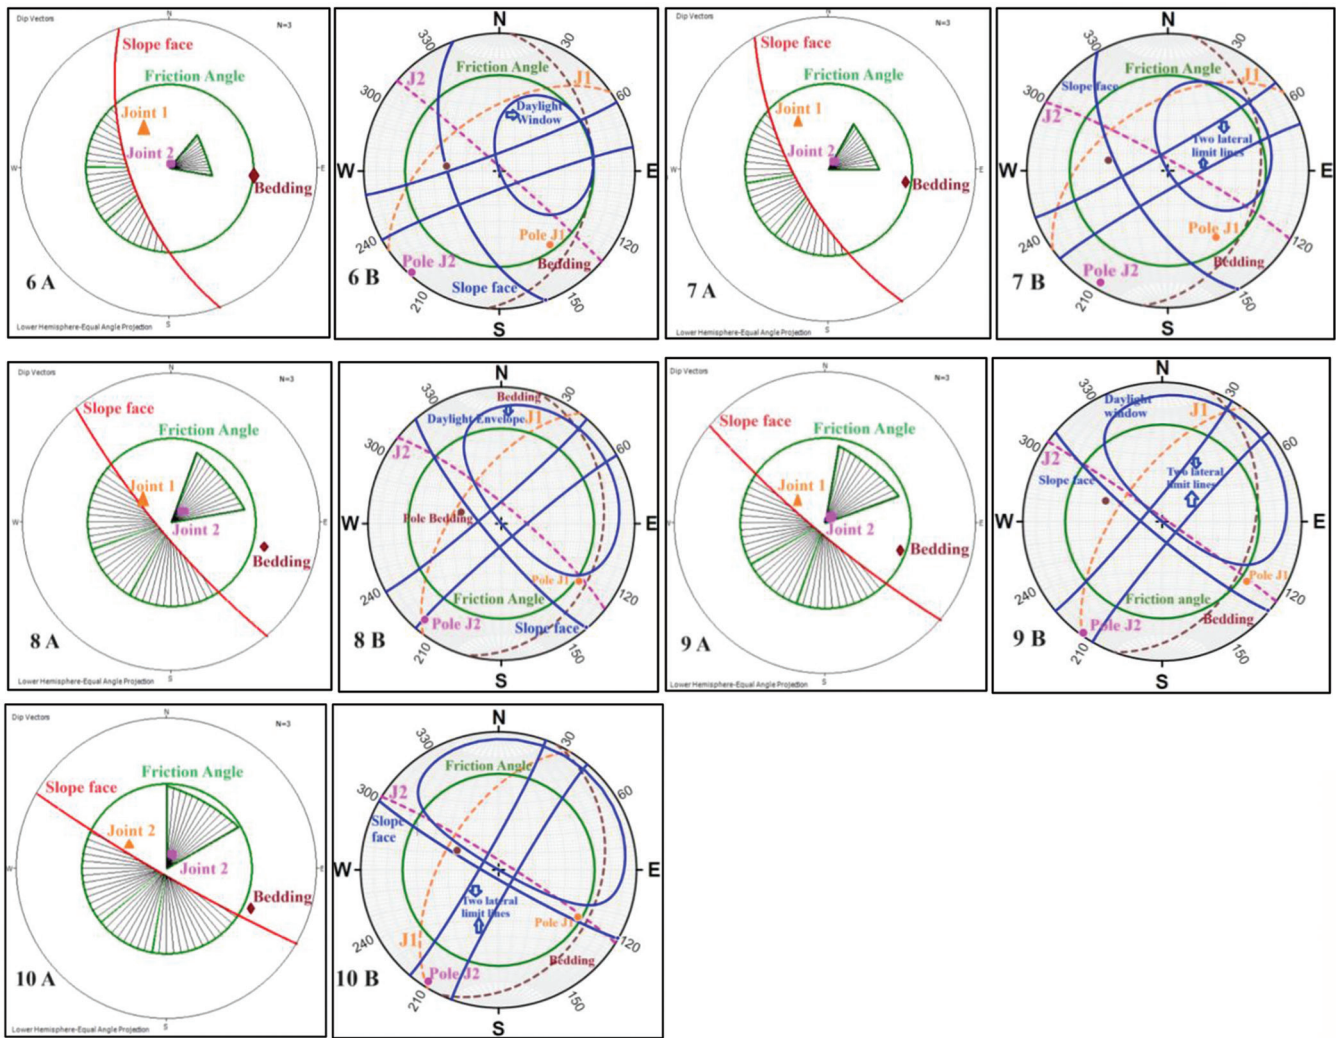
Fig. 5. Stereographic projections and Dip analysis diagrams of stations 6, 7, 8, 9, and 10 of the Hamamok Dam.

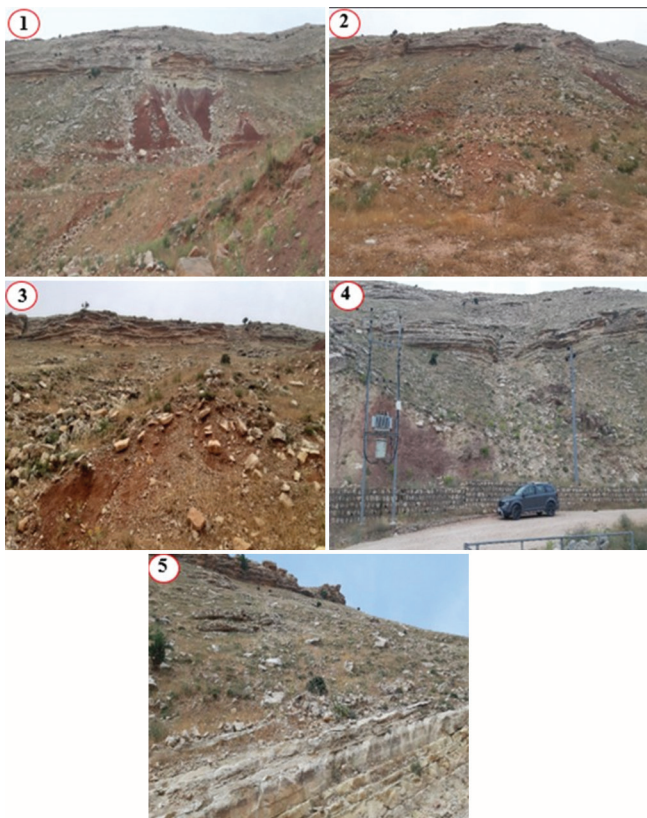
The high values of LPI and failure possibilities in the banks of the Hamamok Dam site (Tables III and IV) indicate that the slopes on both banks are unstable (Figs. 6 and 7). The unstable slopes are attributed to: (1) the Steep slopes of both banks of the valley, which form the lake of the dam (Fig. 2) have gradients of 53.51% and 23.62% of the left and right banks, respectively, (2) the well bedded and jointed hard carbonate rocks of the

Pila Spi Formation, which suffer from toppling (Figs. 6 and 7), (3) the presence of soft claystone beds of the Gercus Formation underlying the carbonate rocks of the Pilea Spi Formation act as a lubricant for sliding and toppling, and (4) the high rates of weathering and erosion in the site.

| Station No. | Kinematic analysis | | DipAnalyst 2.0 software and Stereographic projection results |
|---|---|--|--|
| 1 | The dip of joint 2 and its relation with the slope angle has a minor to moderate effect on the sliding failure because there is almost less difference between them. ($80^\circ < 85^\circ$). | The dip direction of Joint 2 has a main role in sliding as the difference in their direction to the direction of the slope face is $< 20^\circ$. $ 310 - 315 = 5 < 20^\circ$ | The stereographic projection for this station shows that the friction angle is greater than the slope angle and pole of the Joint 2 lies in the critical area for planar failure (between two lateral limit lines on the edge of the daylight window area) Fig. 5. 1B. The analysis by Dip Analysis 2.0 shows that the dip vector point of Joint 2 lies within the critical area for plane sliding criteria Fig. 5. 1A and the numerical analysis by DipAnalyst 2.0 software shows that the value of the factor of safety is 0.57 Table IV. Therefore, the potentiality for plane sliding is high. |
| 2 | The slope angle is almost equal to the dip of Joint 2, thus it has a minor to moderate effect on sliding failure in this station. ($81^\circ < 83^\circ$) | The direction of Joint 2 has a significant role in sliding as the difference in their direction to the direction of the slope face is $< 20^\circ$. $ 300 - 312 = 12 < 20^\circ$ | As is clear in Fig. 5. 2B the friction angle is greater than the slope angle, and the pole of Joint 2 lies within a critical area (between two lateral limit lines in the daylight window area). For DipAnalyst 2.0 software, the analysis shows that there is a medium possibility for sliding by joint 2 which lies on the edge of the critical zone for plane sliding Fig. 5. 2A. The numerical analysis by DipAnalyst 2.0 software shows that the value of the factor of safety for this station is 0.97 Table IV which indicates that the possibility of sliding failure is low. |
| 3 | The dip of the slope is almost equal to the dip of Joint 2, thus it has a minor to moderate effect on sliding failure in this station. ($83^\circ < 85^\circ$) | Joint 2 has a significant role in sliding failure in this station as the difference of its direction to the direction of the slope face is $< 20^\circ$. $ 305 - 318 = 13 < 20^\circ$ | At this station, Joint 2 has the main effect on sliding failure as it is clear in (Fig. 5. 3B) that its pole lies on the edge of the line of the critical area between two lateral limits planes of the daylight window zone for sliding failure. The Analysis by DipAnalyst 2.0 software shows that the probability for sliding failures on the Joint 2 surfaces is potential as it lies within the critical area (Fig. 5. 3A). Therefore, the potentiality of plane sliding exists. The factor of safety for this station is 0.99 (Table IV) therefore the sliding possibility is low. |
| 4 | The dip of joint 2 and its relation with the slope angle has a minor to moderate effect on the sliding failure because there is almost less difference between them. ($80^\circ < 85^\circ$) | In this station, the difference between the dip direction of Joint 2 and the slope face is $< 20^\circ$. Thus it has a main role in sliding failure $ 312 - 315 = 3 < 20^\circ$ | (Fig. 5. 4B) shows that joint 2 has the main effect on sliding failure where it lies within a critical area between two slope limit planes in the daylight window zone. (Fig. 5. 4A) for The DipAnalyst 2.0 software shows that Joint 2 lies on the edge within the critical plane sliding zone. Therefore, the type of failure in this station is plane sliding. Numerical Analysis by DipAnalyst 2.0 software shows that the value of the factor of safety for this station is 0.89 (Table IV). |
| 5 | The dip of joint 2 and its relation with the slope angle has a minor to moderate effect on the sliding failure because there is almost less difference between them. ($85^\circ < 88^\circ$) | The dip direction of Joint 2 has a main role in sliding as the difference in their direction to the direction of the slope face is $< 20^\circ$. $ 307 - 308 = 1 < 20^\circ$ | At this station, joint 2 has the main effect on sliding failure as it's clear in (Fig. 5. 5B) its pole lies within the area between two lateral slope limits planes of the daylight window zone (critical area) for sliding failures. (Fig. 5. 5A) for analysis by DipAnalyst 2.0 software shows that the probability for sliding failures on the Joint 2 surfaces is high, as it lies within the critical area zone for plane sliding failure. Numerical analysis shows that the factor of safety for this station is 0.64 (Table IV). Therefore, the potentiality of plane sliding is high. |

Fig. 6. Right bank station Nos. 1, 2, 3, 4, and 5. Nos. 1 and 4: Active erosion areas indicating unstable slopes. No. 2: Bulged mass in the middle of the slope indicating an unstable slope. No. 3: Recent slid blocks as indicated from the fresh color of the blocks; indicating unstable slope. No. 5: The slope below the cliff is gentler as compared to the other stations; therefore, the amount of slid blocks is smaller and lesser. The reddish brown clastics of the Gercus Formation are overlain by the carbonates of the Pila Spi formation

Based on the acquired data on the stability of both banks and landslide possibility and their type, and because the hard carbonate rocks of the Pila Spi Formation form the top slope part, the main reasons for the possible failure are the orientation and dip amount of the bedding and joint planes; therefore, the protection measures which can be recommended are: (1) Digging a ditch on the top slope and line it by concrete to decrease the infiltration of rainwater to the rocks, (2) the ditch will also decrease the infiltrated water to the soft red claystone, which will form as a lubricant to the overlying hard carbonate rocks of the Pila Spi Formation, (3) to increase

the vegetation cover on the slopes of red soft rocks of the Gercus Formation to decrease the weathering and erosion of the soft clastic rocks which accelerate the toppling and sliding of the hard carbonate rocks, and (4) although we could not recognize very large blocks on the top slope, a detailed check should be done to check if such blocks exist or otherwise. If yes, then bolting to the bedrock should be done.

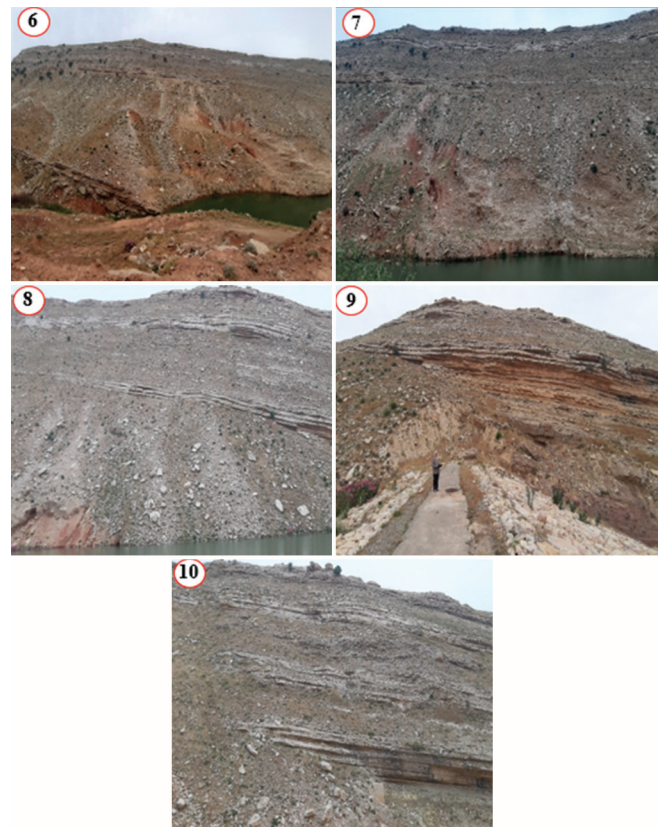
is the situation at stations Nos. 6, 7, 8, 9, and 10. Joint 2 is primarily responsible for the toppling.

Fig. 7: Left bank station Nos., 6, 7, 8, 9, and 10. Nos. 6, 7, and 8: Active erosion areas and groves within the slopes indicating unstable slopes. No. 9: Bulged mass on the left of the slope indicating unstable slope. No. 10: Microfolds in the beds of the Pila Spi Formation, they deformed the beds and increased the instability of the slopes. Note the amount of the accumulated scree in the left side of the slope. The reddish brown clastics of the Gercus Formation are overlain by the carbonates of the Pila Spi Formation.

| Station | Kinematic analysis | Stereographic and Dip analysis 2.0 projection results |
|---|---|--|
| 6 | -The Kinematic analysis in this station shows that the dip direction of Joint 2 is about N41°E dipping into the slope face (S70°W) and for toppling failure to occur it must be within about 10°, but in this station is more than 10° where the pole of Joint 2 lies outside the critical area (Fig. 5. 6B). - Numerical analysis by (Goodman and Bray, 1976): $(90^\circ - \psi f) + \phi j < \psi p$ $(90-60)+31 < 88=(61 < 88)$ indicates that the potentiality of toppling failure is high. | The stereo net's slope stability analysis in (Fig. 6. 6B) shows that the pole of Joint 2 lies outside of the critical area (Daylight window) area. The analysis by DipAnalyst 2.0 software shows that Joint 2, lies on the edge of the shaded area Fig. 6. 6A). Therefore, toppling failure is possible and is increased by the activity of differential weathering and/or erosion of the claystone layer that underwent various degrees of weathering and/or erosion inward for the claystone slope face with a decrease in bearing capacity toward the slope. |
| 7 | -The Kinematic analysis in this station shows that the dip direction of joint 2 is about N30° E dipping into the slope face (S60°W) and for toppling failure to occur it must be within about 10°, but in this station is more than 10°. -According to numerical analysis by (Goodman and Bray, 1976). $(90-65)+31 < 84=(56 < 84)$ | Slope stability analysis by Stereo nets (Fig. 6. 7B) indicates that the toppling failure possibility is low by Joint 2 as the pole of joint 2 lies outside the critical area (Daylight window). The analysis by DipAnalyst 2.0 software shows that Joint 2, lies on the edge of the shaded area (Fig. 6. 7A). This means that the possibility for toppling failure is low because the activity of differential weathering and/or erosion of rock masses below the slopes leads to gradation in weathering, the blocks move gradually and then topple. |
| 8 | The Kinematic analysis in this station shows that the dip direction of joint 2 is about N39°E dipping into the slope face (S50°W) and for toppling failure to occur it must be within about 10°, but in this station, it is <10° and as it is clear in (Fig. 5. 8B) the pole of Joint 2 lies in the critical area (between two lateral limit lines within the daylight envelope area). Therefore, the potentiality of toppling failure is high. - According to equation analysis. $(90-80)+31 < 80=(41 < 80)$ | The stereographic projection in this station (Fig. 6. 8B) shows that the possibility of toppling failure is high where the pole of Joint 2 lies in the critical area (Daylight window) on the edge of the two lateral limit lines for toppling failure. This means the blocks in this station are more prone to toppling failure than sliding where the pole of Joint 2 is far and out of the sliding failure criteria. The analysis by DipAnalyst 2.0 software shows that Joint 2, lies on the edge of the shaded area (Fig. 6. 8A), where toppling failure is possible and is increased by the activity of differential weathering and/or erosion of rock masses below the slopes. |
| 9 | The Kinematic analysis shows that the dip direction of joint 2 has a main effect on toppling failure to occur in this station as it is about N28°E dipping into the slope face (S40°W) within about 10°. -Numerical analysis according to equations by (Goodman and Bray, 1976) shows that $(90-82)+31=88=(39<88)$ Therefore, in this station potentiality of toppling failure is high. | The stereo net's slope stability calculation for station 9 (Fig. 6. 9B) shows that the possibility for toppling failure in this station is high, where the pole of Joint 2 lies inside the critical area (Daylight window) and between the two lateral limit lines. This means that blocks in this station are more prone to toppling failure than sliding where the pole of joint 2 is far and out of the sliding failure criteria. The analysis by DipAnalyst 2.0 software shows that Joint 2, lies within the triangular shaded area (area for toppling failure) (Fig. 6. 9A) |
| 10 | The Kinematic analysis shows that the attitude of joint 2 has a main effect on toppling failure to occur in this station as it is about N32°E dipping into the slope face has attitude (S30°W) within about 10°. - According to equation analysis $(90-85)+31=85=(36<85)$. Therefore, the potentiality of toppling failure is almost high. | The stereographic analysis for this station (Fig. 6. 10B) shows that the possibility of Toppling failure is high, where the pole of joint 2 lies inside the critical area (Daylight window) This means the blocks in this station are more prone to toppling failure than sliding where the pole of Joint 2 is far and out of the sliding failure criteria. The analysis by DipAnalyst 2.0 software shows that Joint 2, lies on the edge of the triangular shaded area (Figure 6. 10A), where toppling failure is possible. |
