The Recovery of Historical Buildings in Post-war Aleppo

Yara Aboasfour[†] and Lígia Nunes

ARO-The Scientific Journal of Koya University
Vol. XII, No. 2 (2024), Article ID: ARO.11488. 8 pages
DOI: 10.14500/aro.11488

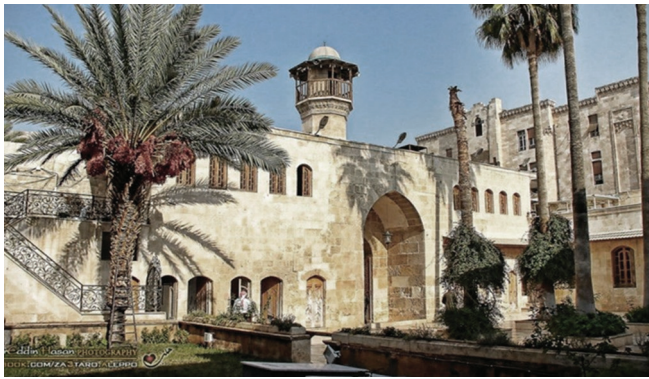
Fig. 2. Sultaniyah school before the war (UNESCO, 2018b).

The Sultaniyah School, also the Royal School, is located toward the door of the Citadel of Aleppo. It is considered one of the most important Islamic monuments, as its construction dates to the Ayyubid era. King Al-Zahir Ghazi started the school construction, only completed in 1223 AD (Fig. 2). The school mosque was a square-shaped room roofed with a distinctive dome. The mosque also contains one of the rare niches regarding the installation and the marble's quality. With many types of stones and marble, it also contained entirely accurate carving works and columns with Corinthian capitals made of marble, standing on both sides of the mihrab (Al-Ghazzi, 1992).

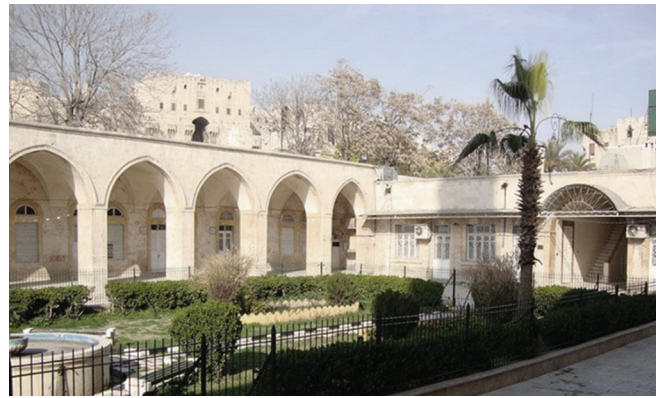
Fig. 6. Khusrawiyah before the war (UNESCO, 2018b).

architecture in the city. This complex introduced a new architectural and urban concept to Aleppo by blending Ottoman design principles with local building traditions and materials as shown in Fig. 6. The mosque's grand portal features two marble columns with engravings, a door under a dome, and a patterned decoration stone on each side. The ceramic tiles that adorn the windows, the mihrab (altar), and the pulpit within the prayer hall are examples of this fusion (Al-Ghazzi, 1992). From Fig. 7 it is essential to note that the overall loss of historical significance associated with the Khusrawiyah complex is severe and critical.

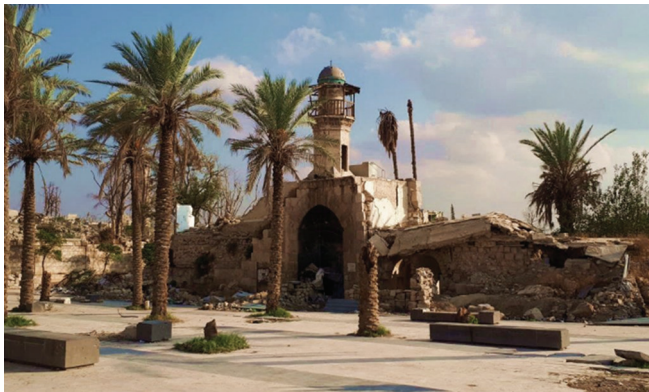
Fig. 3. Sultaniyah School after the war. Source: Author.

Its physical condition is distorted because the building was bombed in December 2014. The school was destroyed except for remains on the northern side of the courtyard and the minaret as shown in Fig. 3, though they are also heavily ruined (UNITAR, 2015). It is historically significant as it contains the mausoleum of al-Zahir Ghazi, the famous ancient ruler of Aleppo. Architecturally, it was rich in inscriptions and included splendid architectural features representing the Ayyubid style. Consequently, the overall historical loss is categorized as severe and critical.

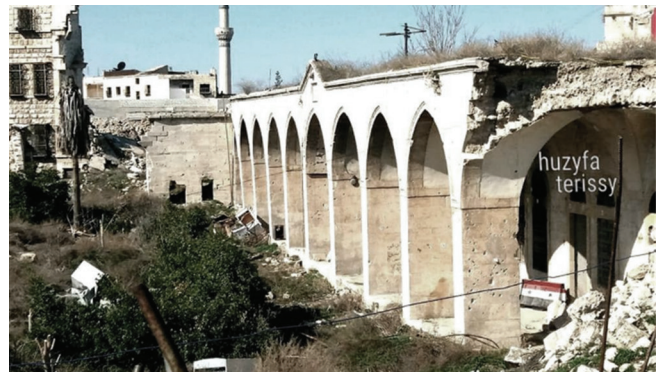
Fig. 7. Khusrawiyah after the war (UNESCO, 2018b).

The Khusrawiyah complex, designed by Mimar Sinan, was constructed in 1544 during the Ottoman reign. It was the first school in Aleppo, Syria, known as the religious secondary, and it was described as Azhar of Aleppo. It stood near the citadel to the west across its ring road (Al-Ghazzi, 1992). However, in 2014, the entire complex, except for the northern entrance, was destroyed during the Battle of Aleppo. The central mosque within the complex suffered extensive damage, causing its collapse and leaving behind a sizable crater (UNITAR, 2015).

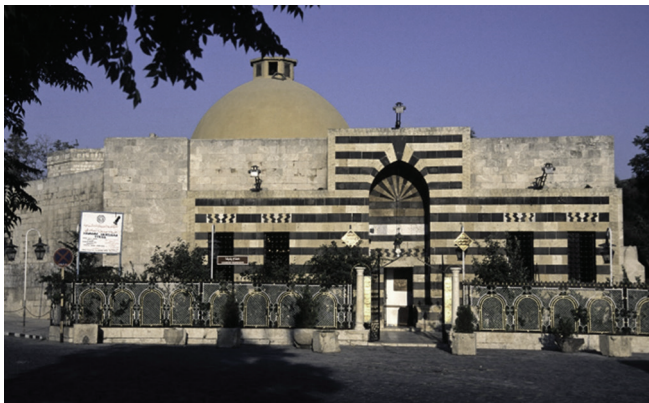
Fig. 4. Yalbga Bath before the war (UNESCO, 2018b).

It occupies a significant location at the foot of the Citadel's entrance and faces the street with a monumental façade built in polychrome masonry, of the Mamluk style. The façade of the bathroom is decorated with alternating bricks in black and yellow (Figs. 4 and 5 show the facade of the bath before and after the war). The dome of the outer section rests on the shoulders of the Iwan vaults with triangular spherical corners and is decorated with floral motifs inscribed in red and blue. The floor of the inner section is paved with small alternating stones in black and yellow in coordinated geometric styles (Al-Ghazzi, 1992).

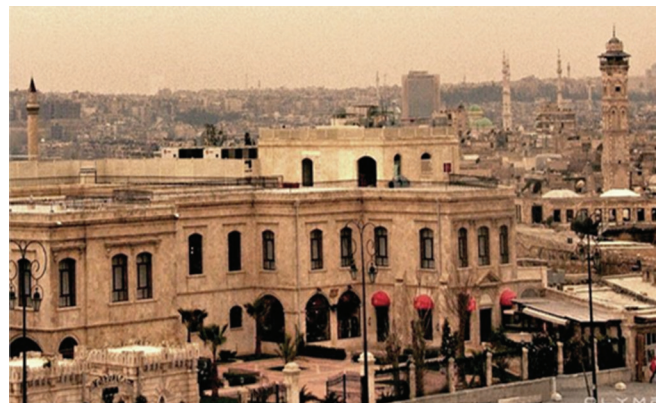
Fig. 8. The Carlton Hotel before the war (Aboasfour, 2019).

The construction of the hotel building, initially known as the Strangers Hospital, commenced in 1819 and spanned 48 years, culminating in its completion in 1897. In 1892, it was the seat of the municipality. The facility's inauguration officially took place in 1900 under the auspices of Governor Jamil Pasha. The primary purpose of the establishment was to provide medical treatment for poor people and strangers, and its establishment was made possible through subsidies and contributions from various benefactors (Al-Ghazzi, 1992). The building was transformed into the National Hospital, comprising 32 rooms, two spacious residences, two elongated salons, and a pharmacy. In 1988, it underwent further conversion into a health institute before being repurposed as a hotel (Fig. 8), capitalizing on its exceptional location and captivating view near the Aleppo Citadel (Al-Ghazzi, 1992). Arches, arcades, and a spacious lobby characterize the Ottoman building of the Carlton Hotel. It is considered one of the preeminent archaeological highlights in Aleppo. However as shown in Fig. 9, the hotel is currently suffering severe deterioration due to two bombing incidents in February 2014 and May 2014 (UNITAR, 2015).

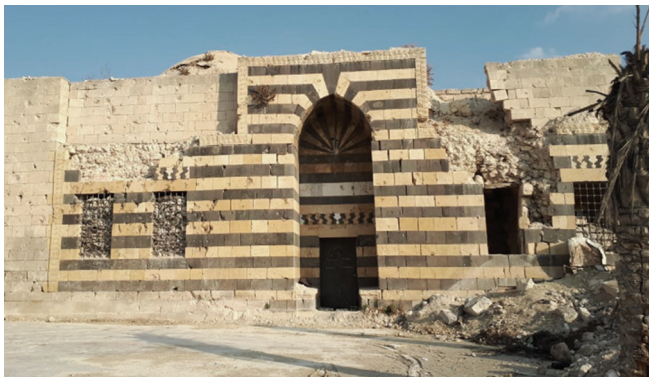
Fig. 5. Yalbga Bath after the war. Source: Author.

It is considered one of the most important historical sites due to its archeological, structural, artistic, and architectural features. As one of the few Mamluk public baths to have preserved its original function. It was still standing and preserving its original character until the bombing in April 2014. Taking this into consideration, the overall historical loss is categorized as severe (UNITAR, 2015).

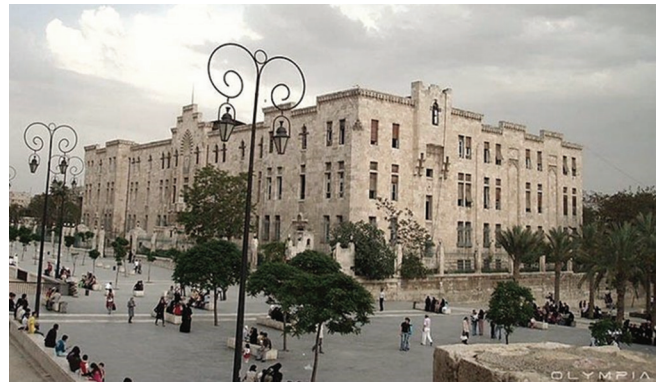
Fig. 10. The New Serail before the war (Aboasfour, 2019).

In constructing the new serail, the concept of building a novel government edifice traces its origins back to the latter stages of the Ottoman era. Nonetheless, the construction process encountered interruptions and was recommenced in 1928 after establishing the State of Syria during the period of the French Mandate. On 15 April 1933, the New Serail was officially inaugurated, assuming the role of the customary headquarters for the governor and mayor of the city. It served as the governmental seat until 2008 when the new headquarters of the Aleppo City Council was inaugurated (Fig. 10). In 2011, the Serail underwent a renovation to transform it into a hotel. Positioned south of the Citadel and east of its primary entrance, the building featured a U-shaped design, encompassing three floors and a basement. Its central area comprises a spacious atrium flanked by rooms on both sides and a sizable garden to the south (Al-Ghazzi, 1992).

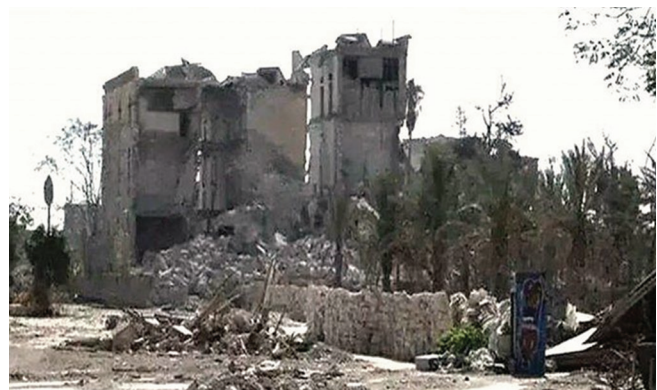
Fig. 11. The New Serail after the war (Aboasfour, 2019).

Between 2014 and 2015, the site witnessed complete structure demolition. The central section and the entire eastern wing suffered irreparable damage due to the excavation of a tunnel beneath the building, followed by the strategic placement of explosives, resulting in the formation

of a substantial crater (UNITAR, 2015). Considering the historical significance of the new serail as the established above for the city's governor and mayor since the nascent years of Syria, coupled with its noteworthy contribution to the local landscape of modern architectural expression, the loss incurred is deemed severe and critical (Fig. 11).
