Structural Behavior of Reinforced Concrete Beams Incorporating Foamed Glass as Aggregates

Dawood S. Atrushi

Department of Civil Engineering, College of Engineering, University of Duhok,
Duhok, Kurdistan Region – F.R. Iraq

ARO-The Scientific Journal of Koya University
Vol. IX, No.1 (2021), Article ID: ARO.10746, 60 pages
DOI:10.14500/aro.10746

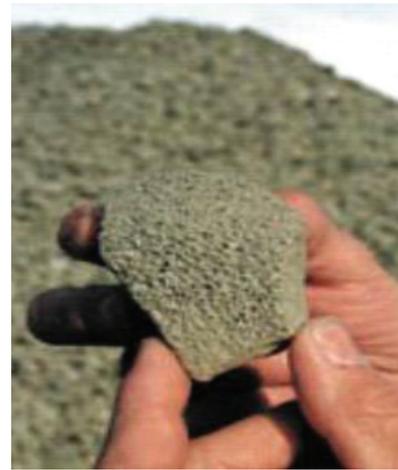
Fig. 1. Foam glass coarse particle.

The cement used was ordinary Portland cement. The fine aggregates used were river sand with particles ranging from 63 μm to 4 mm in size. The coarse aggregates were natural gravel and stones with particles ranging from 4 mm to 20 mm in size. The foam glass coarse particles, shown in Fig. 1, used as partial replacement of natural coarse aggregates were also similar in size ranging from 4 mm to 20 mm, where particle size distribution or grading is done according to BS EN 933-1:1997. Foam glass was originally manufactured from waste glass by generating a gas in glass at a temperature between 700°C and 900°C, where foaming agents such as calcium sulfate (CaSO_4) or calcium carbonate (CaCO_3) are also added (Hurley, 2003). The gas expands thus producing a structure of cells to form a porous body. The density of coarse aggregate and FG is 1200 kg/m^3 and 267 kg/m^3 , respectively.

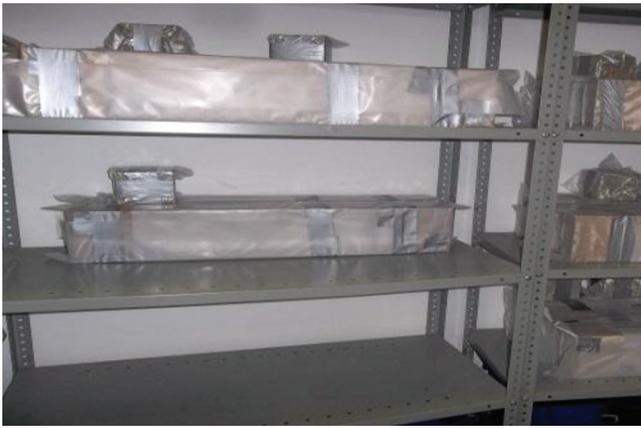
Fig. 4. Specimen wrapped with plastic sheets.

finish and top surface. The completed beams and cubes were then left for settling down for approximately 24 h at room temperature. The following day they were de-molded and marked with the corresponding mix proportions. The beams and cubes were wrapped with plastic sheets then cured at room temperature (at about 20°C). They were in the curing process for 28 days (Fig. 4). The cubes were not placed inside the curing tank to maintain consistency with the beams which were left for curing at room temperature.
